**Coal Combustion Waste Impoundment
Round 5 - Dam Assessment Report**

Winyah Generating Station (Site #004)

**Santee Cooper
Georgetown, South Carolina**

Under Contract Number: EP-09W001727
January 2011

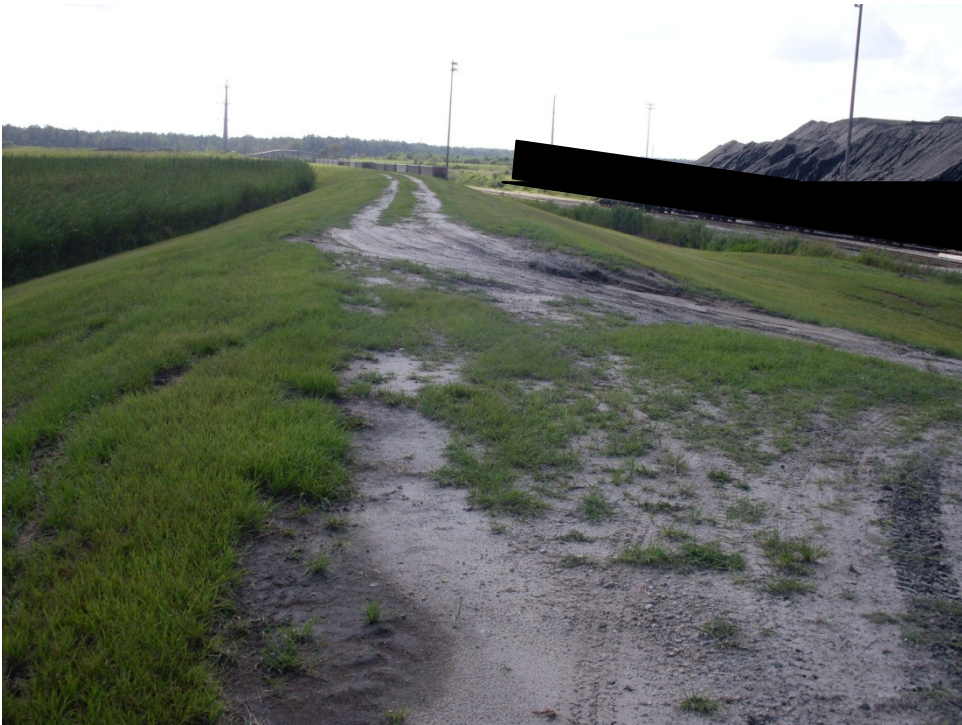
Photo BS-3: Crest of Perimeter Dike North Side of South Ash Pond Perimeter Dike at Access Road – Viewed West.

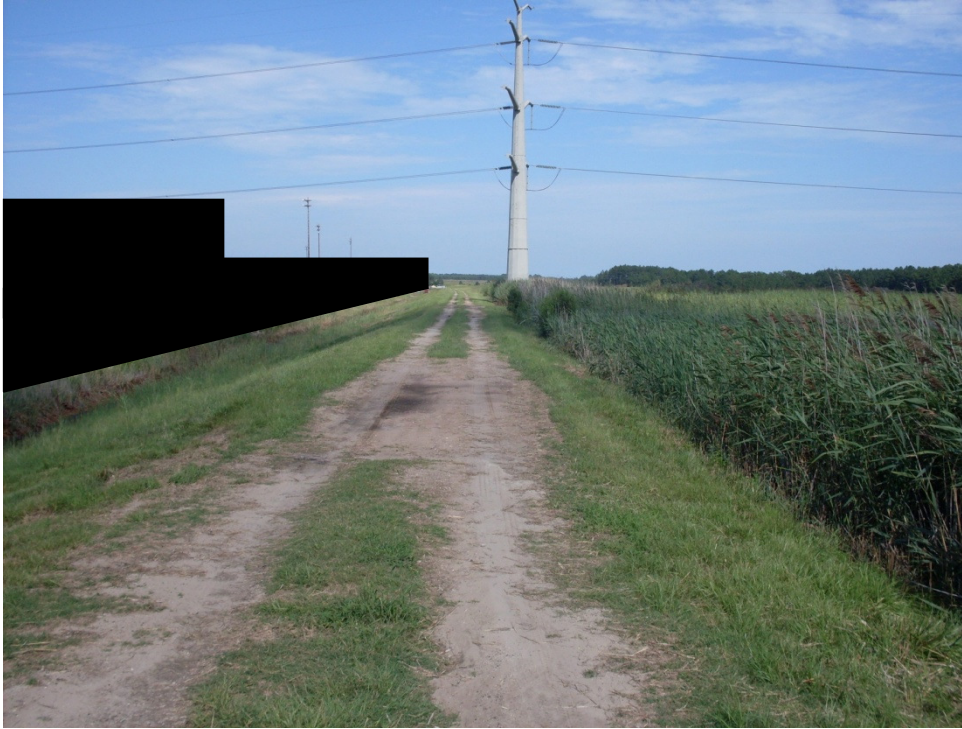
Photo BS-4: Crest of Perimeter Dike North Side of South Ash Pond – Viewed East.

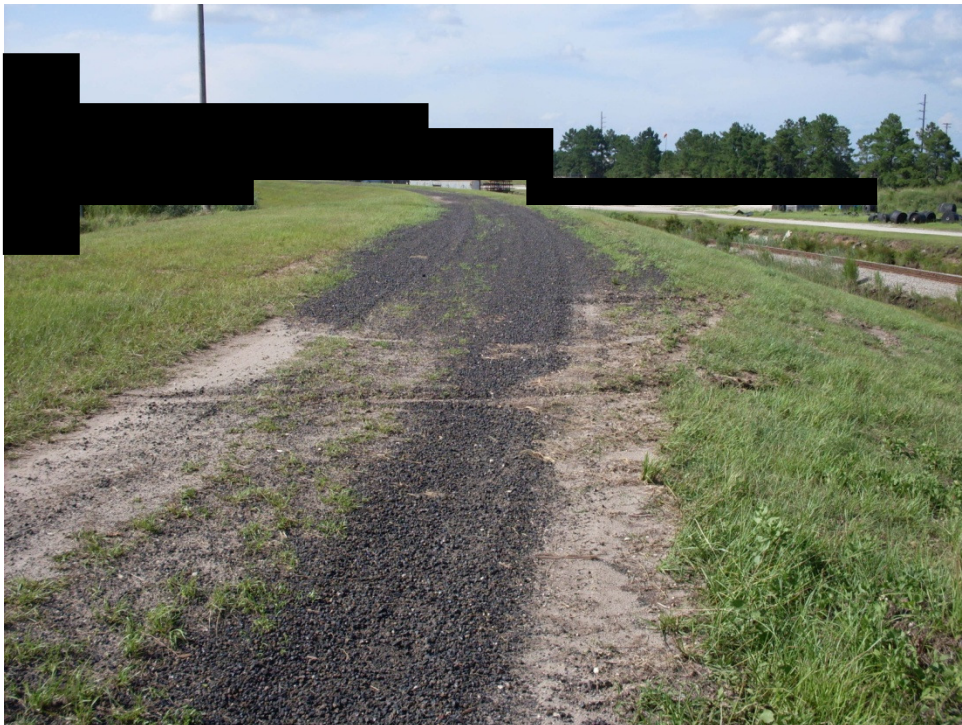
Photo BS-5: Crest of Perimeter Dike on East Side of South Ash Pond Near Decant Tower – Viewed North.

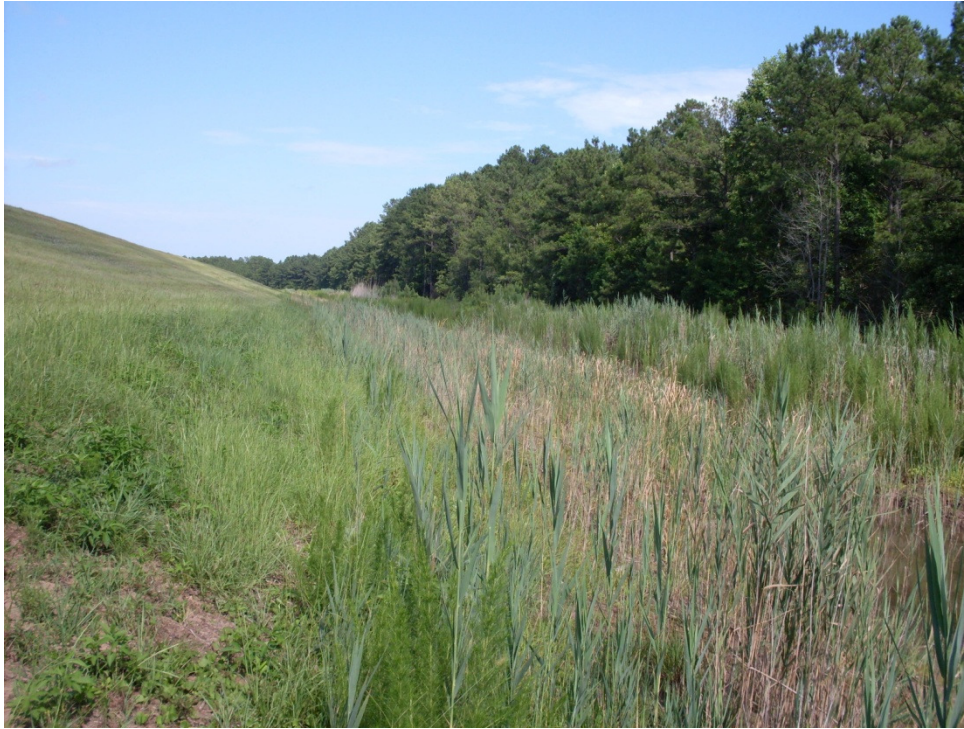
Photo BS-6: Outside Slope and Toe of Perimeter Dike at Southwest Bend of South Ash – Viewed East.

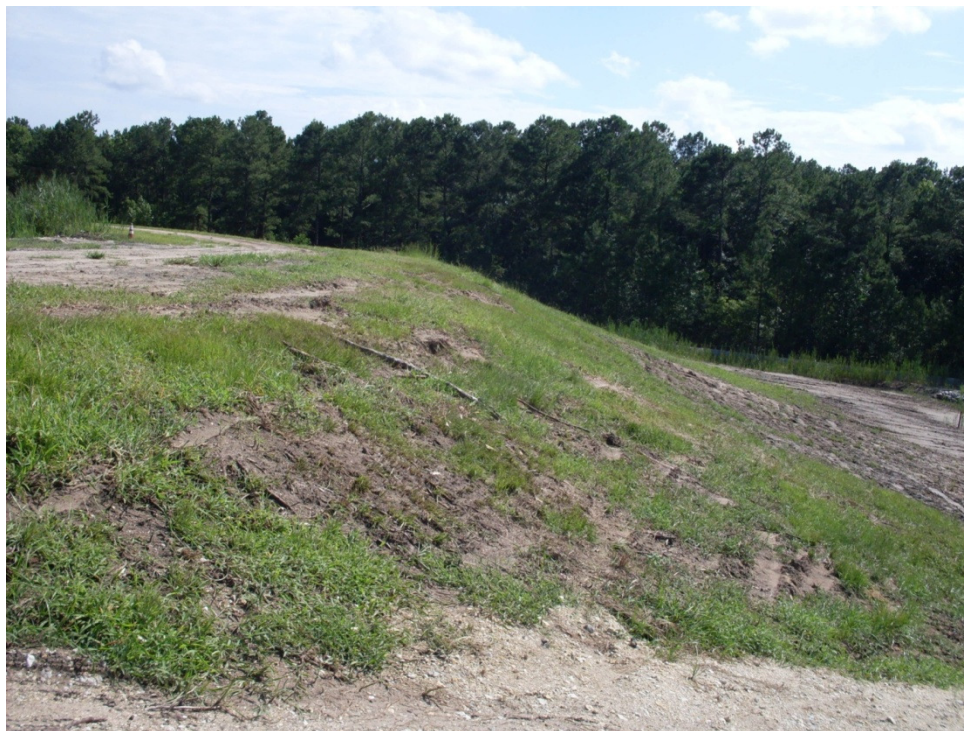
Photo BS-7: Crest and Outside Slope of Perimeter Dike on West Side of South Ash Pond.

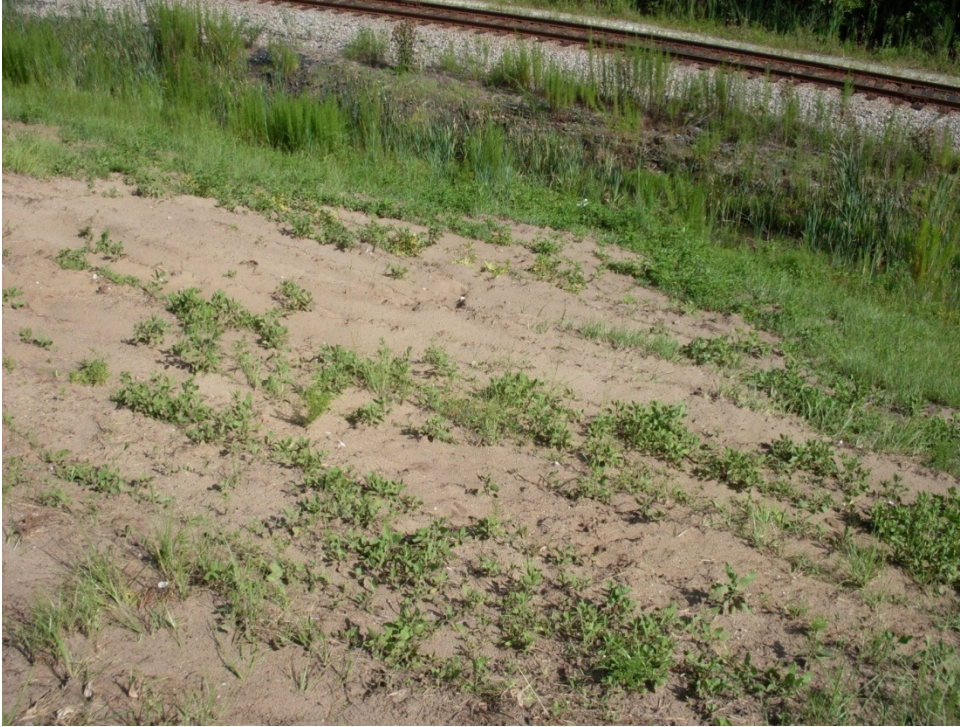
Photo BS-8: Area of Sparse Vegetation Outside Toe of Perimeter Dike South Side of Ash Pond Near Southeast Corner.

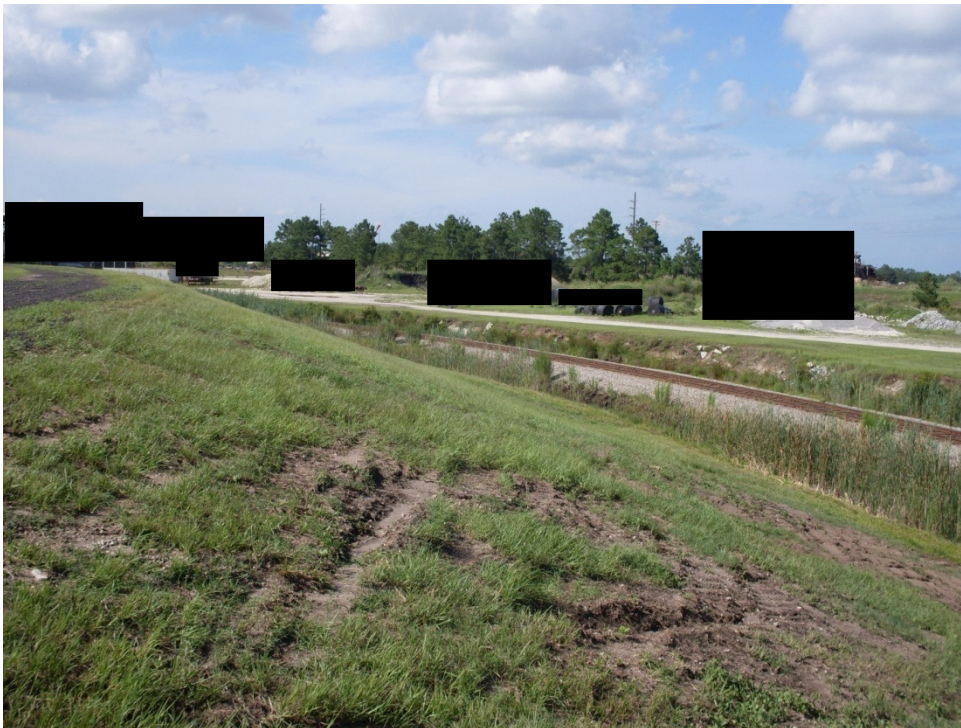
Photo BS-9: Outside Slope of Perimeter Dike East Side of South Ash Pond Near Decant Tower – Viewed North.

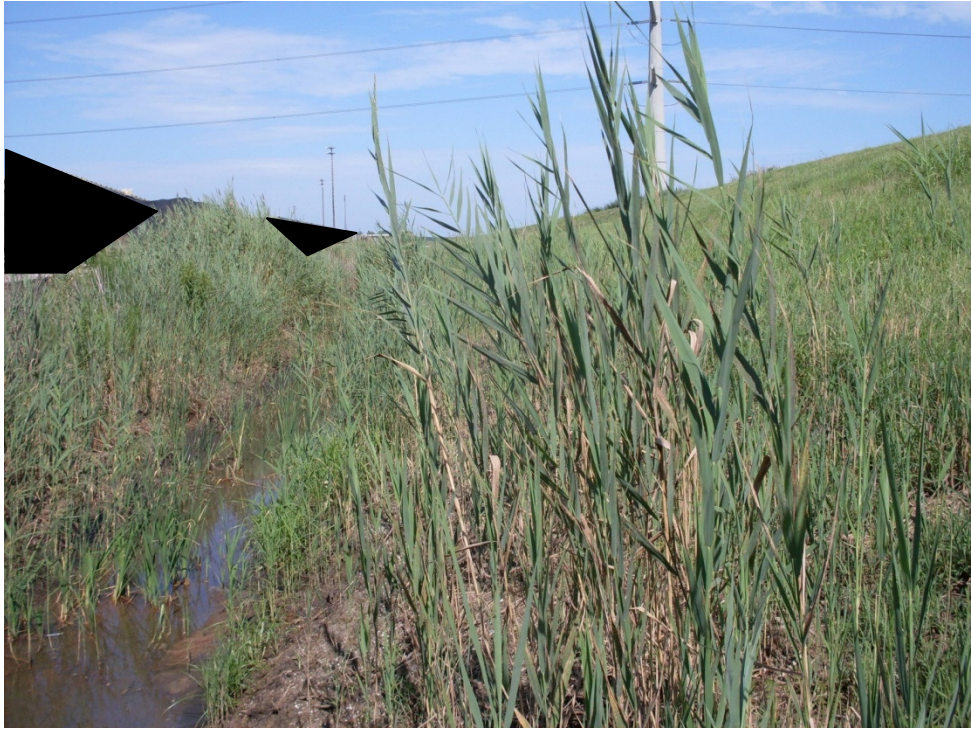
Photo BS-14: Ditch Along Outside Toe of Perimeter Dike North Side of South Ash Pond – Viewed East.

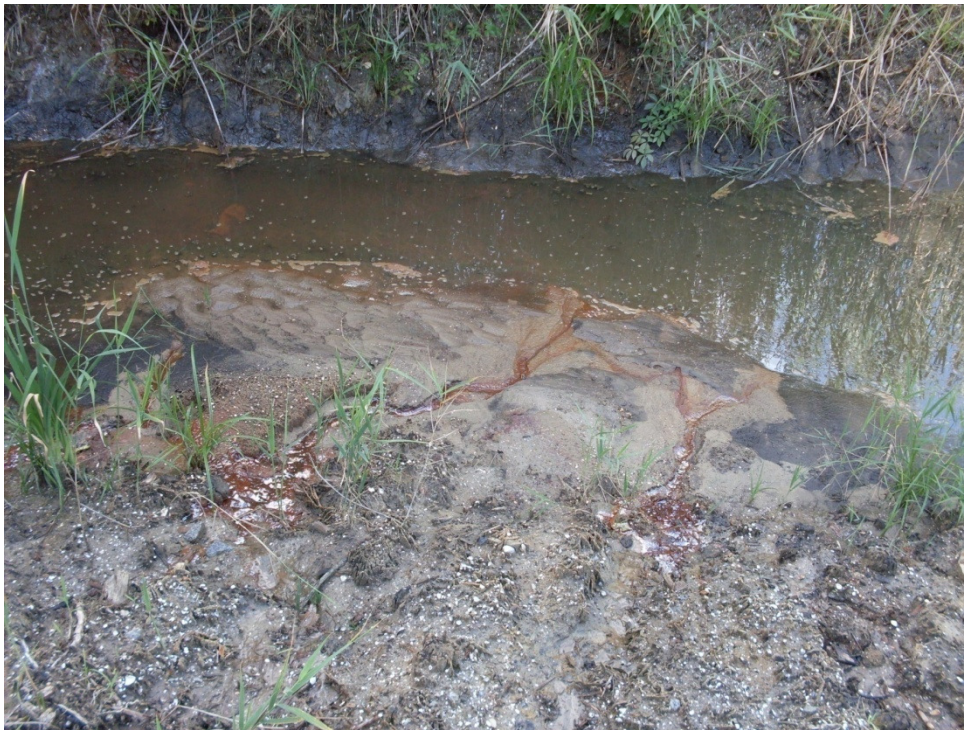
Photo BS-15: Small Seeps at Outside Toe Ditch North Side of South Ash Pond.

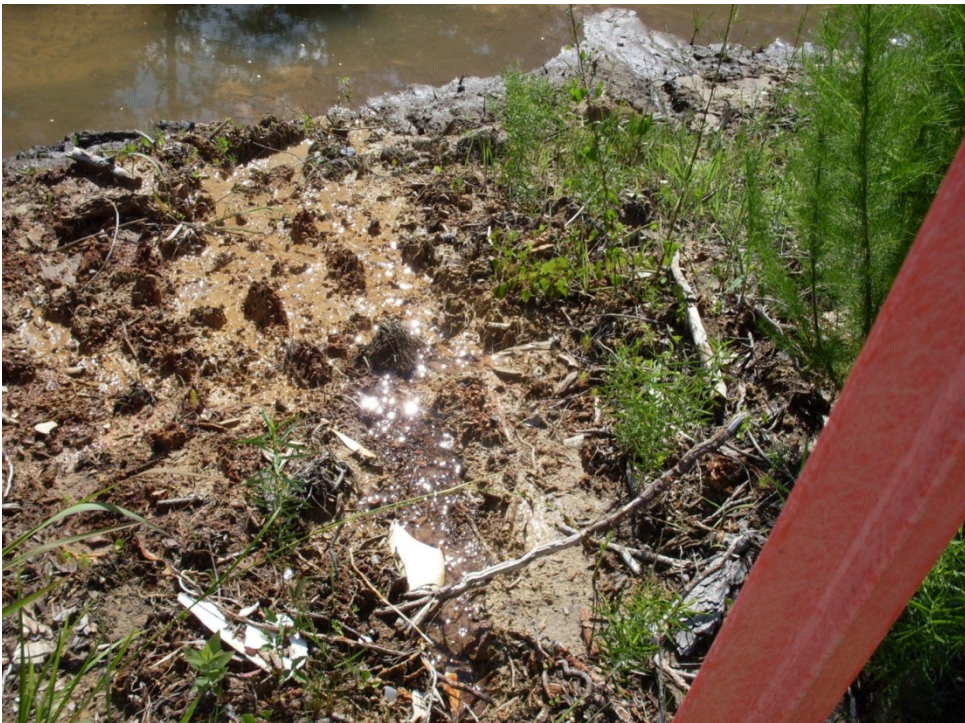
Photo BS-19: Wet Ground and Seepage from Toe Drain PVC Pipe Outlet at Outside Toe of South Ash Pond Perimeter Dike at Southwest Bend End.

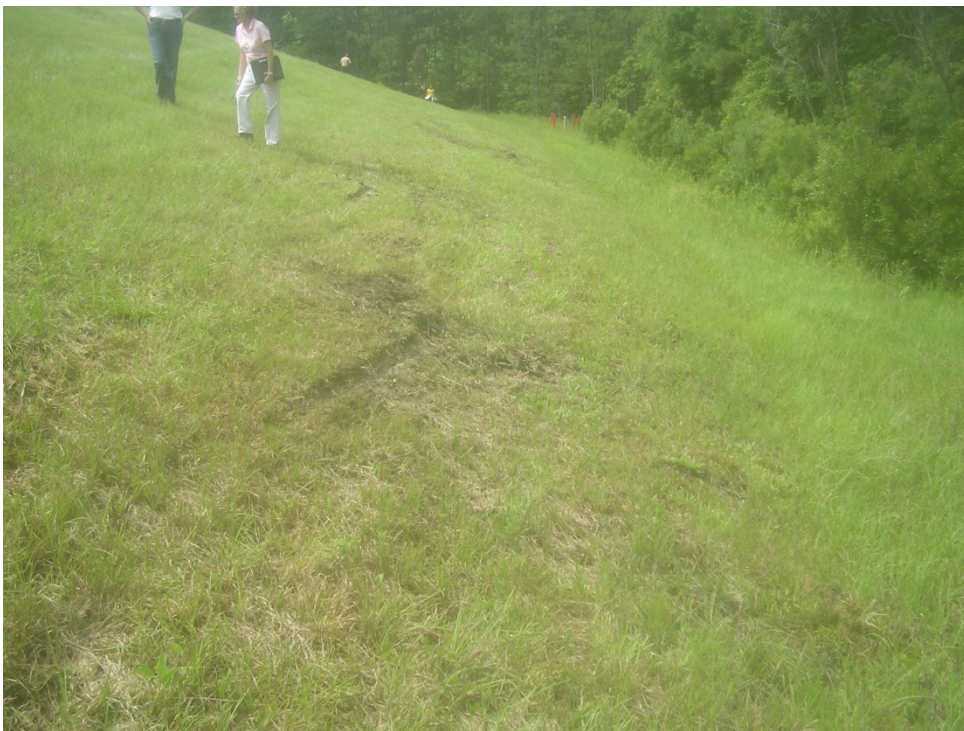
Photo BW-9: Outside Toe of Perimeter Dike West Side of West Ash Pond – Viewed South (Note Mower Ruts Due to Wet Soil).

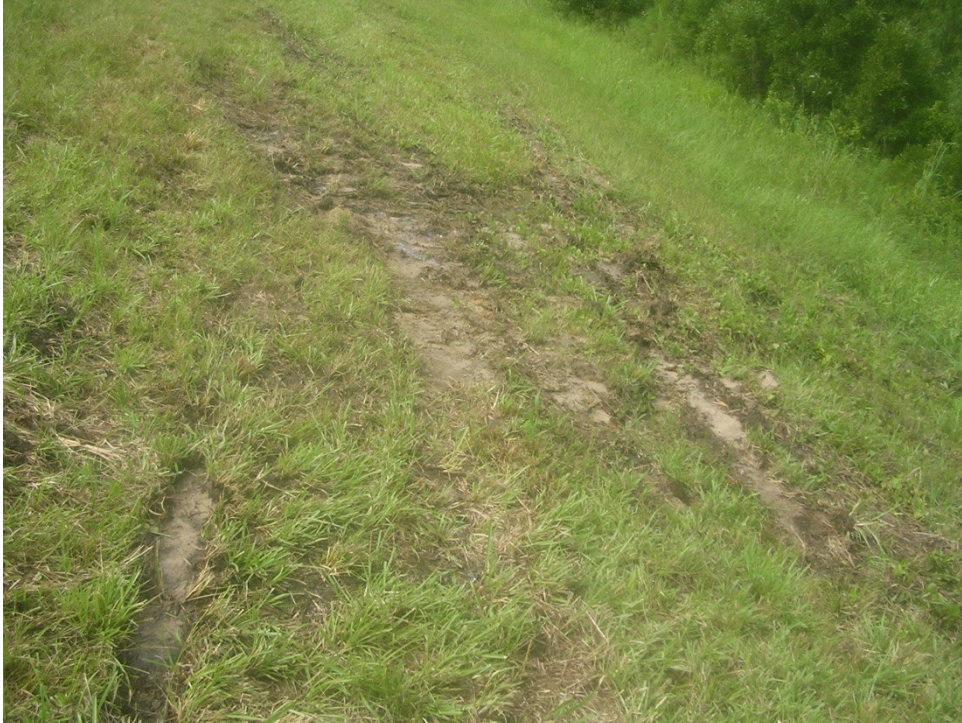
Photo BW-14: Wet Soil Area Outside Toe of Embankment Perimeter Dike
West Side of West Ash Pond.

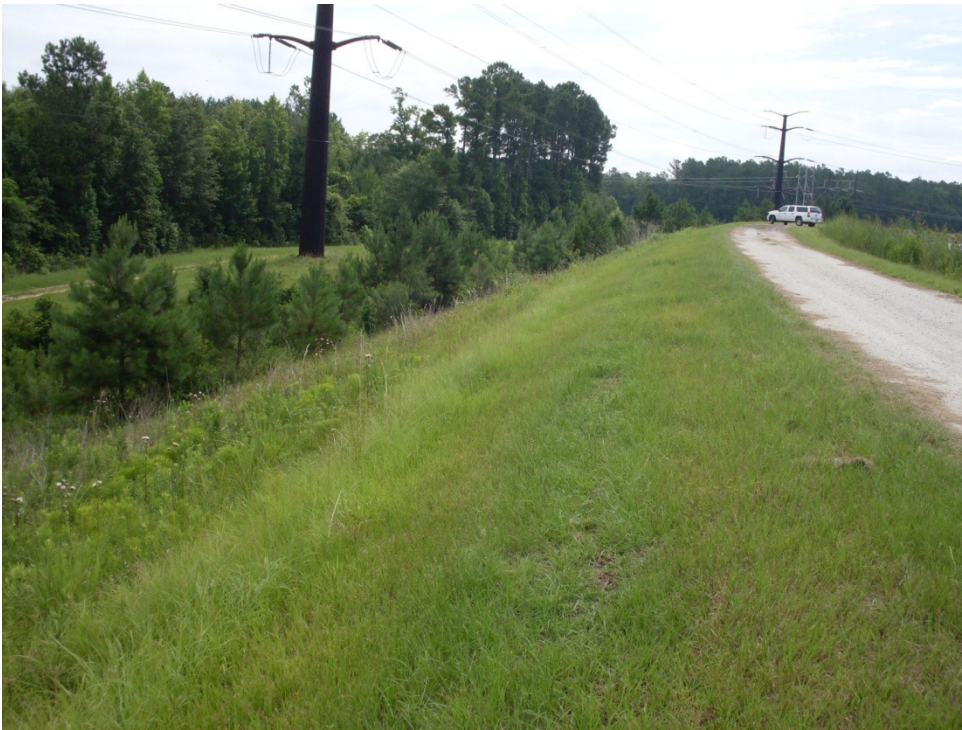
Photo B3-10: Outside Slope of Perimeter Dike Northwest Side of Unit 3 & 4 Slurry Pond – Viewed East.

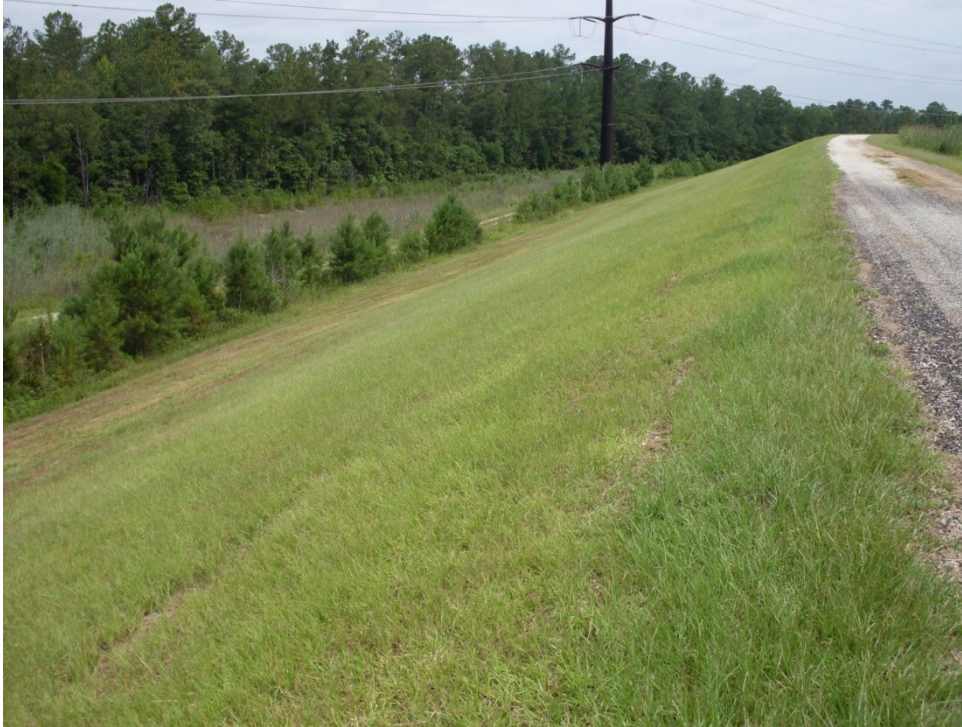
Photo B3-11: Outside Slope of Perimeter Dike West Side of Unit 3 & 4 Slurry Pond – Viewed North.

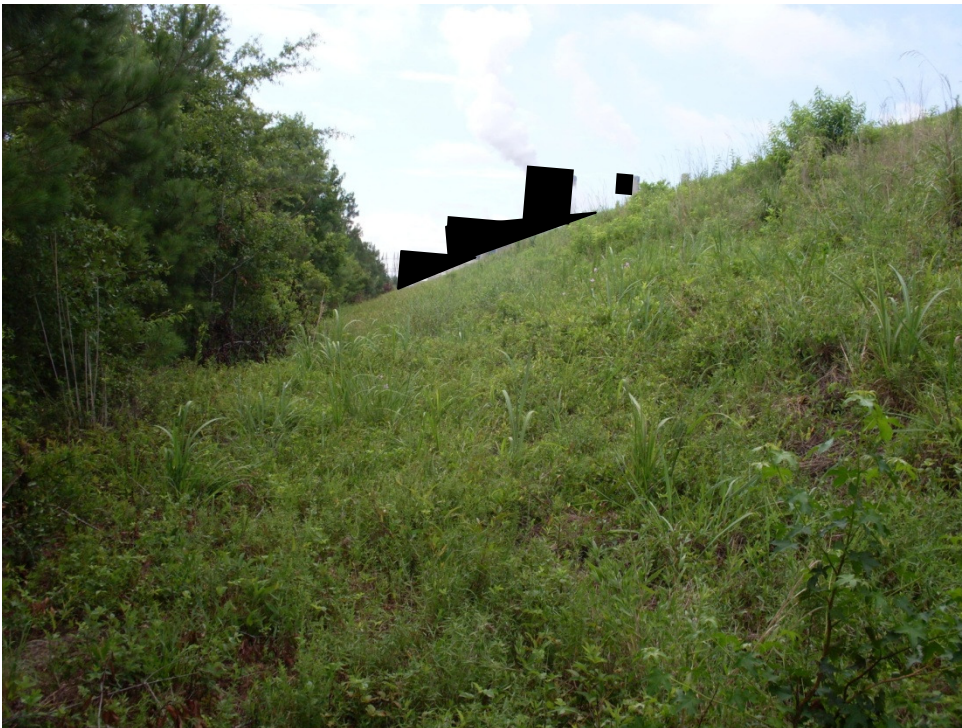
Photo B3-12: Outside Toe of Perimeter Dike Northeast Side of Unit 3 & 4 Slurry Pond – Viewed Southeast.

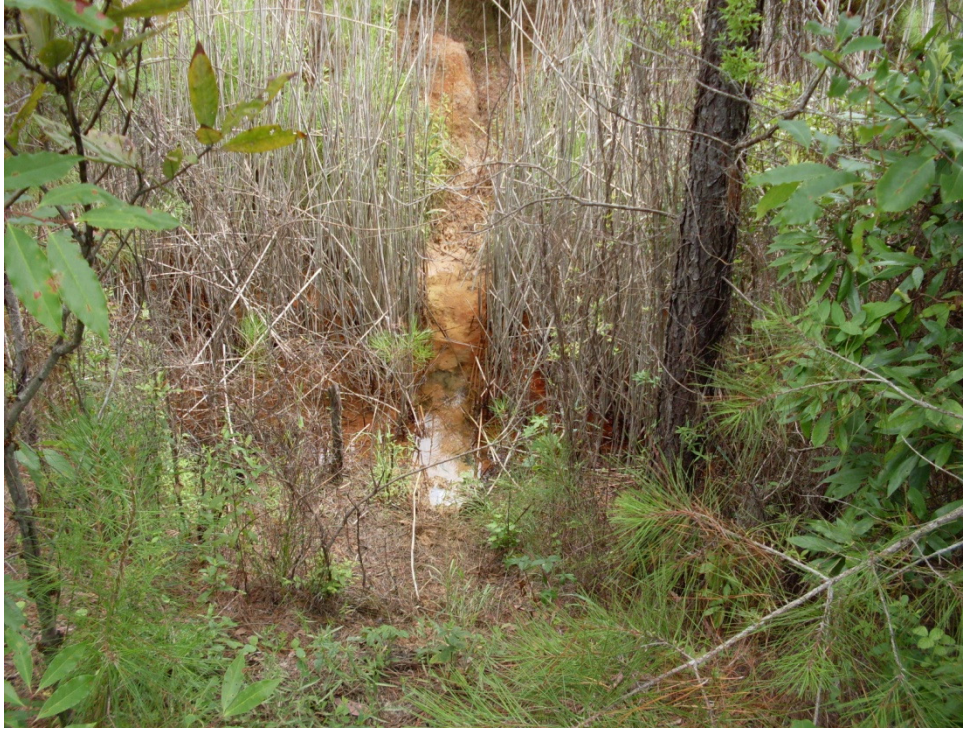
Photo B3-13: Outside Toe of Perimeter Dike Northeast Side of Unit 3 & 4 Slurry Pond (Note Overgrown Toe Ditch).

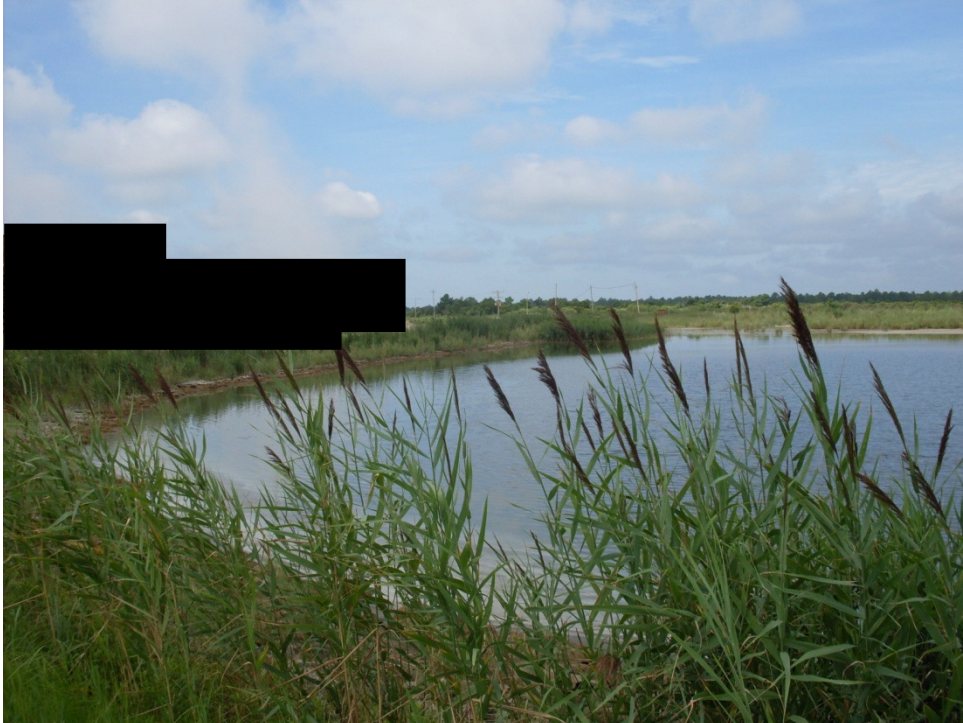
Photo B3-15: Inside Slope of Perimeter Dike Southeast Side of Unit 3 & 4 Slurry Pond - Viewed South.

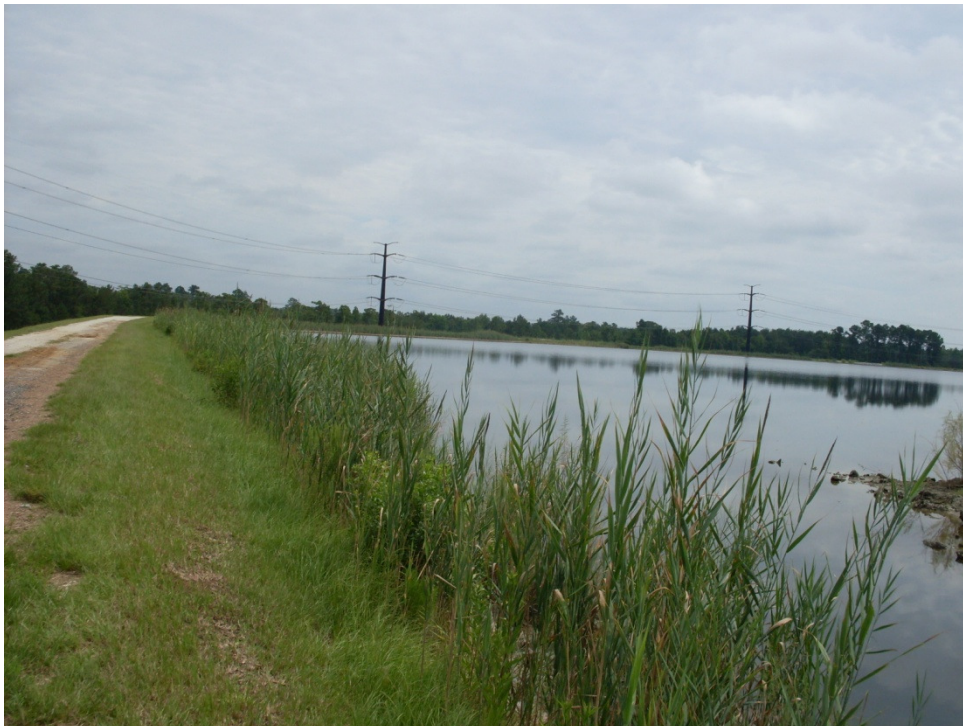
Photo B3-16: Inside Slope of Perimeter Dike West Side of Unit 3 & 4 Slurry Pond – Viewed North.

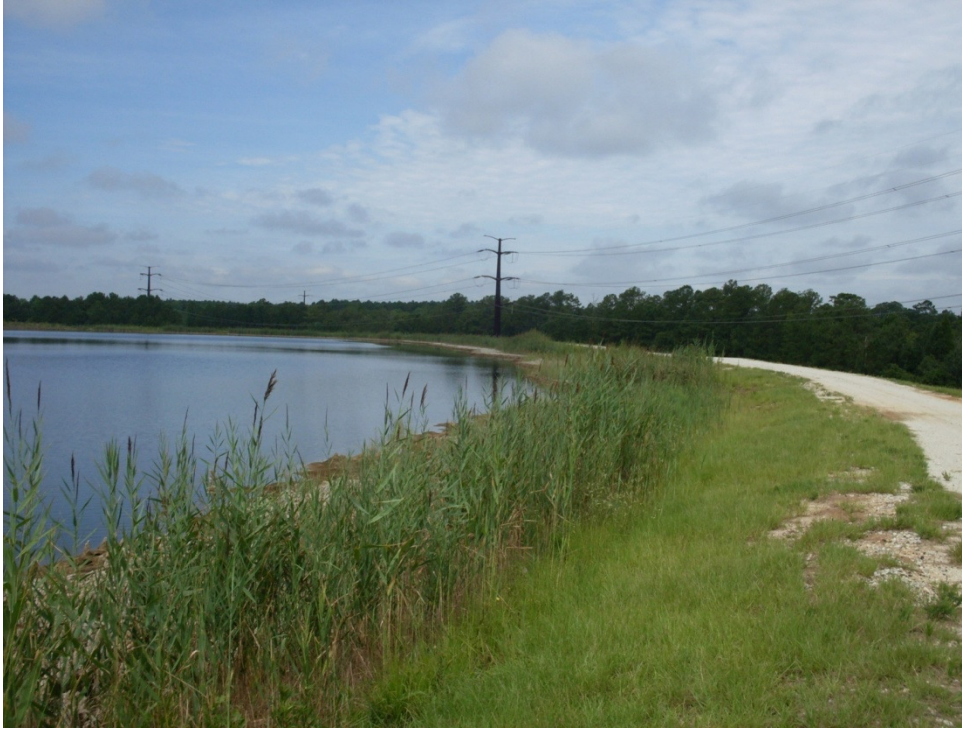
Photo B3-17: Inside Slope of Perimeter Dike at Northwest Side of Unit 3 & 4 Slurry Pond – Viewed West.

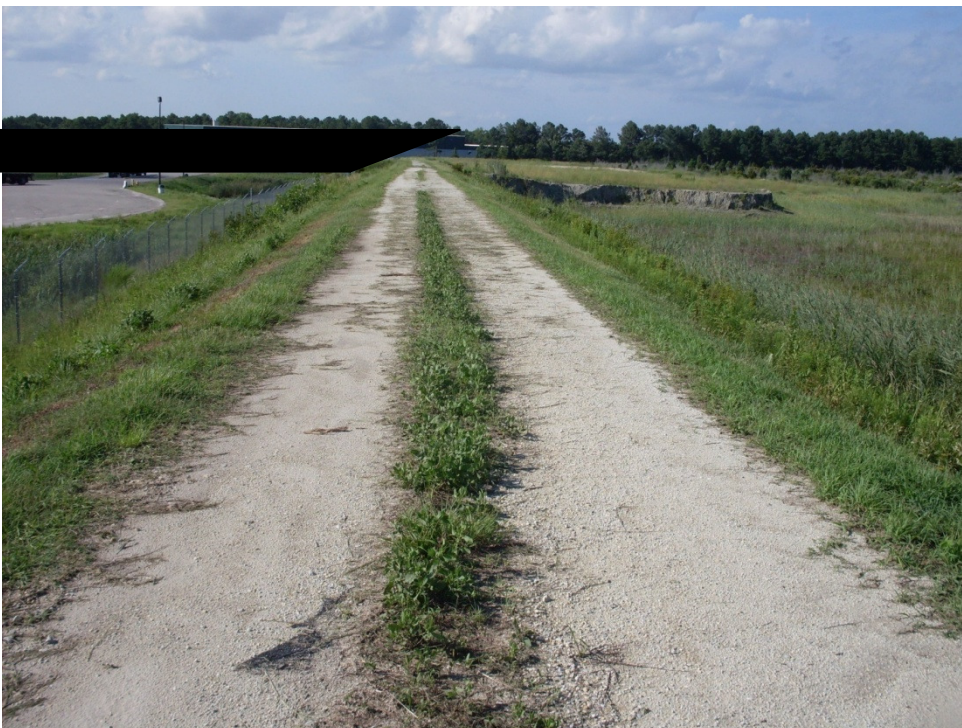
Photo B2-1: Crest of Perimeter Dike West Side of Unit 2 Slurry Pond– Viewed North.

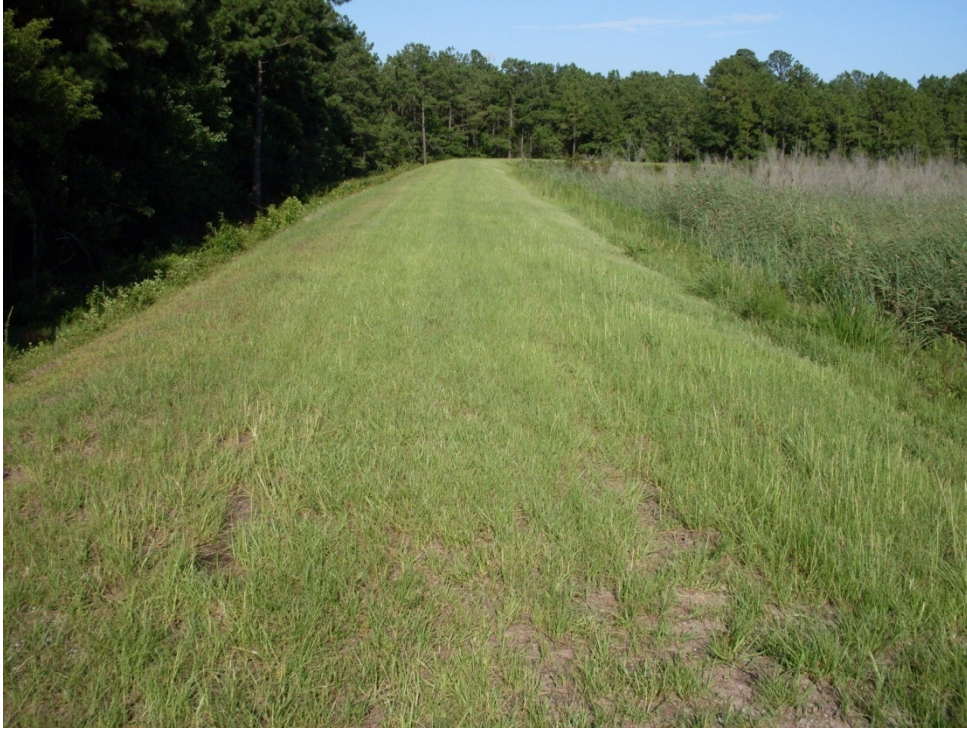
Photo B2-2: Crest of Perimeter Dike North Side of Unit 2 Slurry Pond East of Cross Dike– Viewed East.

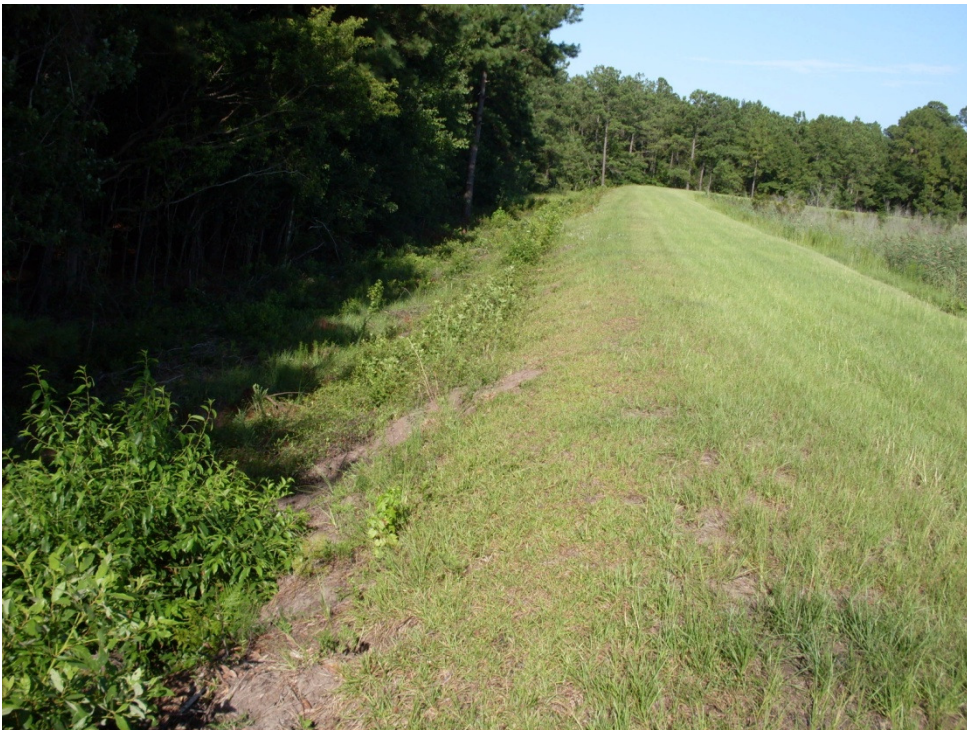
Photo B2-3: Crest of Perimeter Dike North Side of Unit 2 Slurry Pond East of Cross Dike – Viewed East.

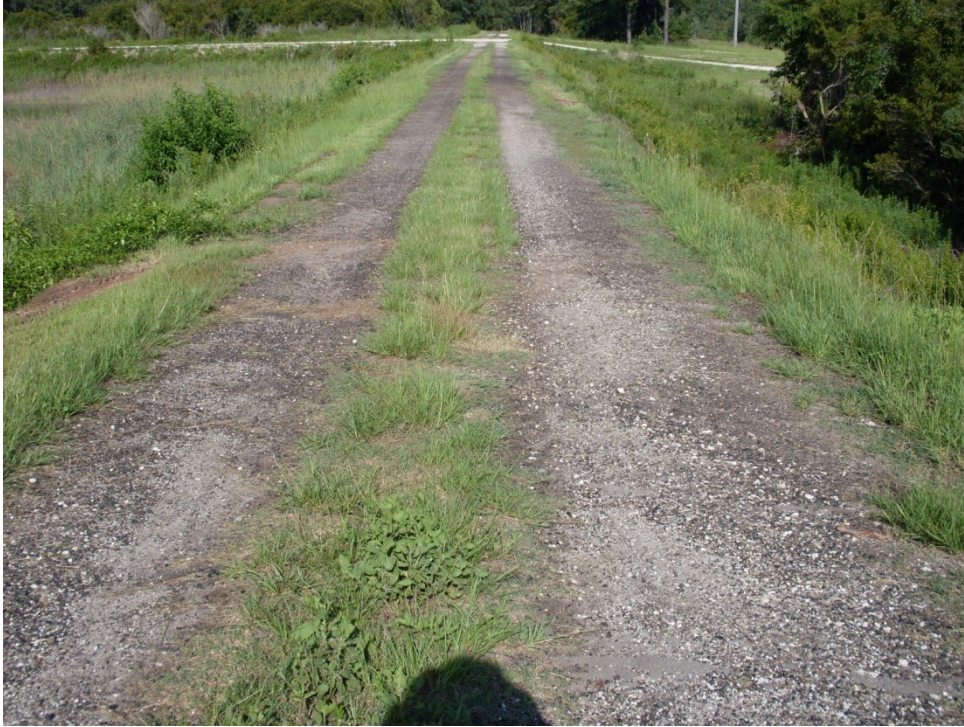
Photo B2-4: Crest of Perimeter Dike South Side of Unit 2 Slurry Pond West of Cross Dike – Viewed East.

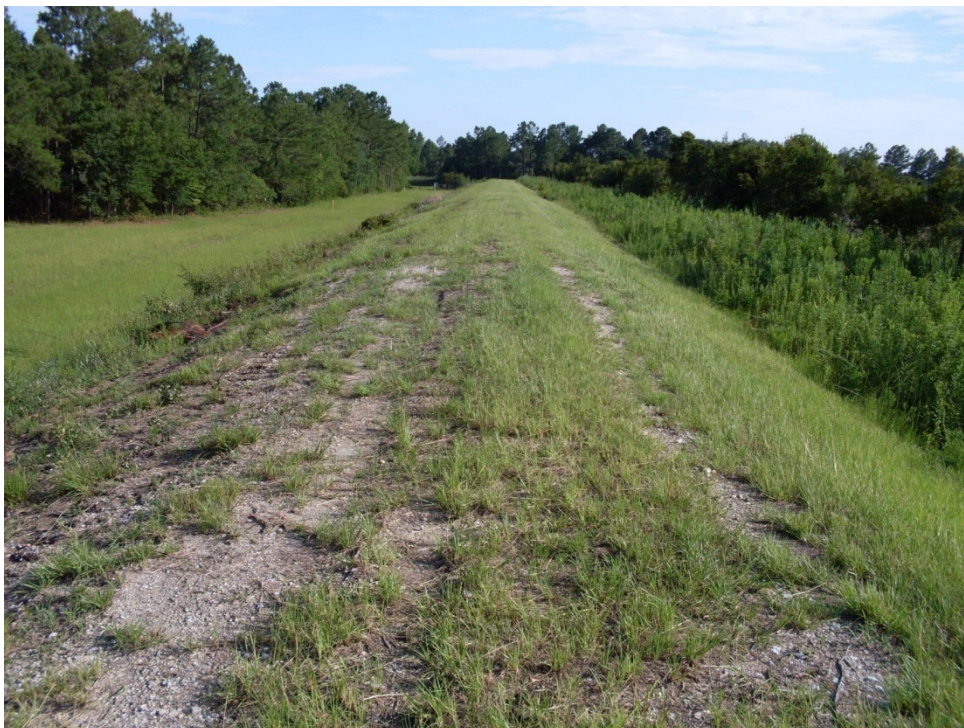
Photo B2-5: Crest of Perimeter Dike East Side of Unit 2 Slurry Pond– Viewed South (Note Sparse Grass Cover).

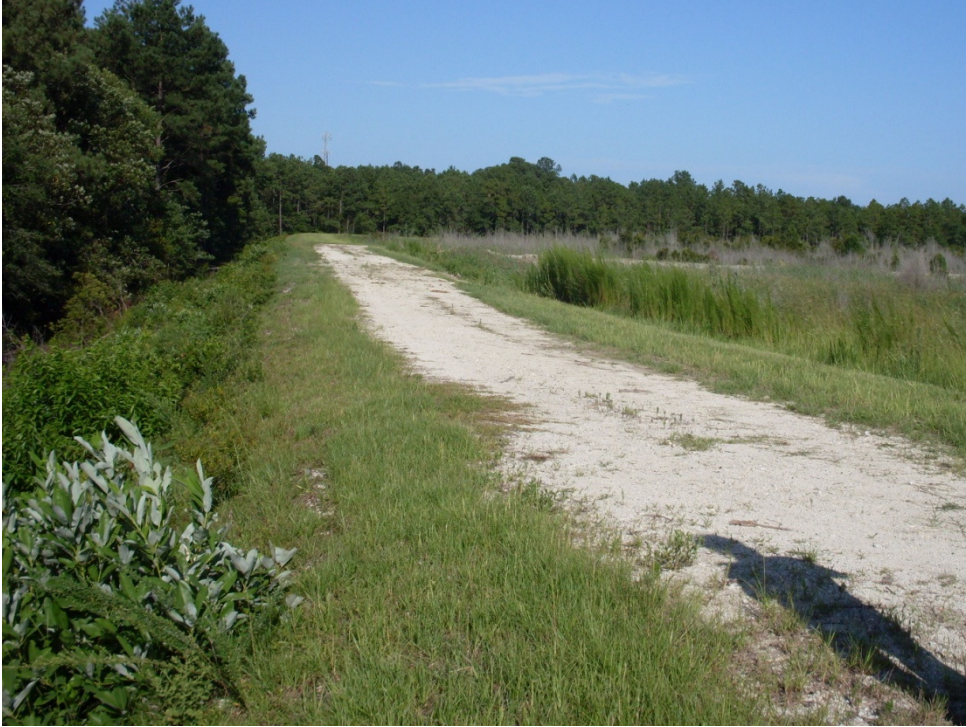
Photo B2-6: Crest of Perimeter Dike North Side of Unit 2 Slurry Pond West of Cross Dike – Viewed East.

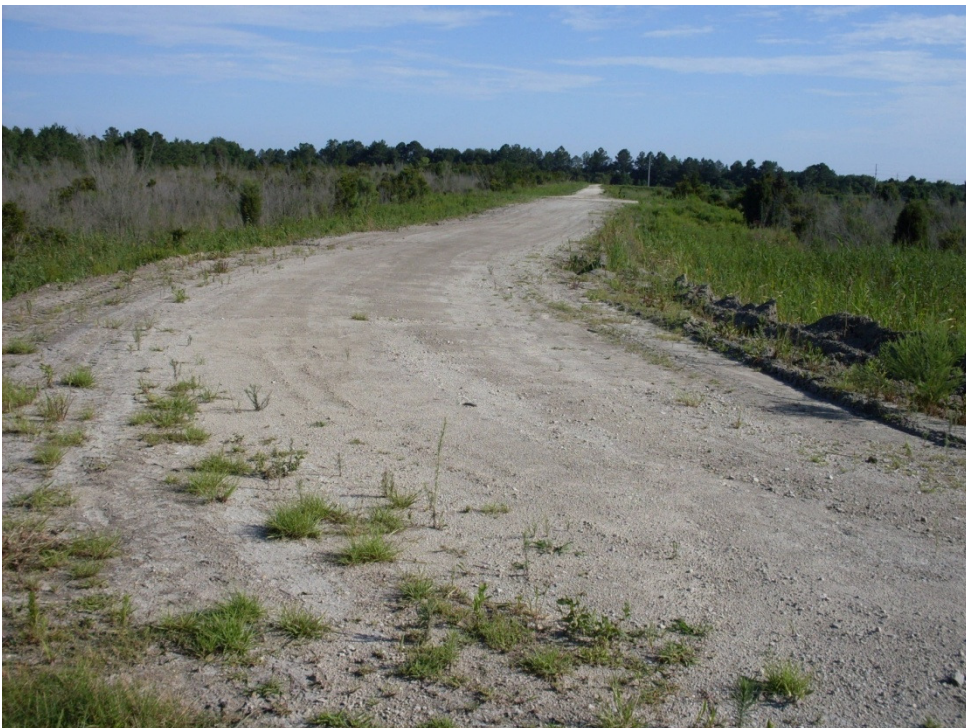
Photo B2-7: Crest of Cross Dike in Unit 2 Slurry Pond– Viewed South (Original Middle “Finger Dike” Had Been Recently Extended Northerly To The North Perimeter Dike To Divide The Pond Into Two Cells).

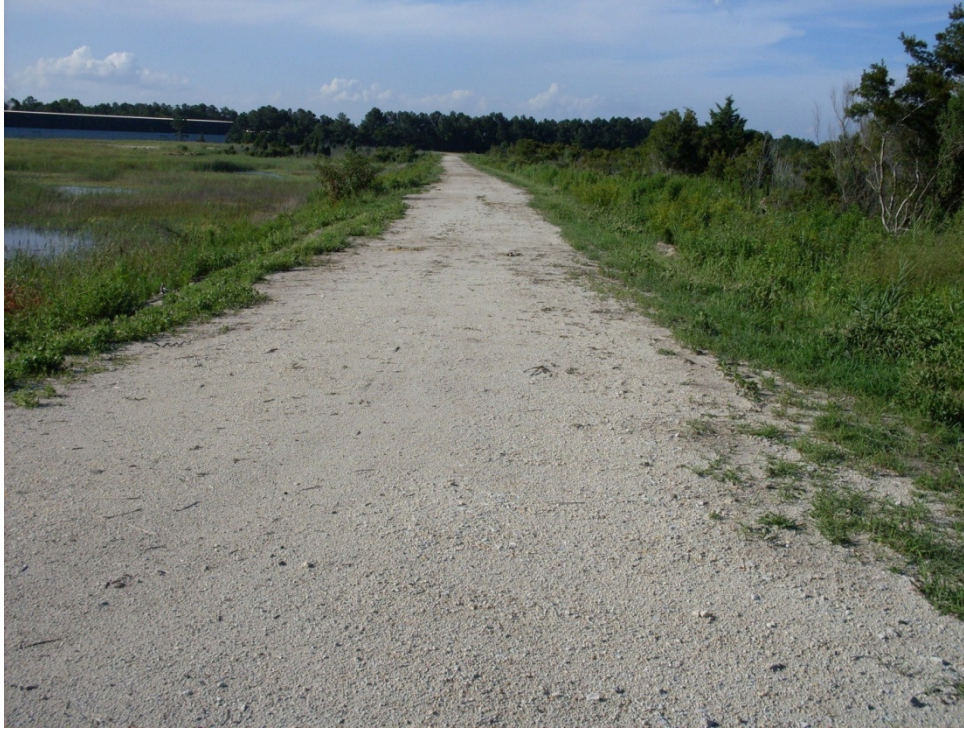
Photo B2-8: Crest of Cross Dike in Unit 2 Slurry Pond– Viewed North.

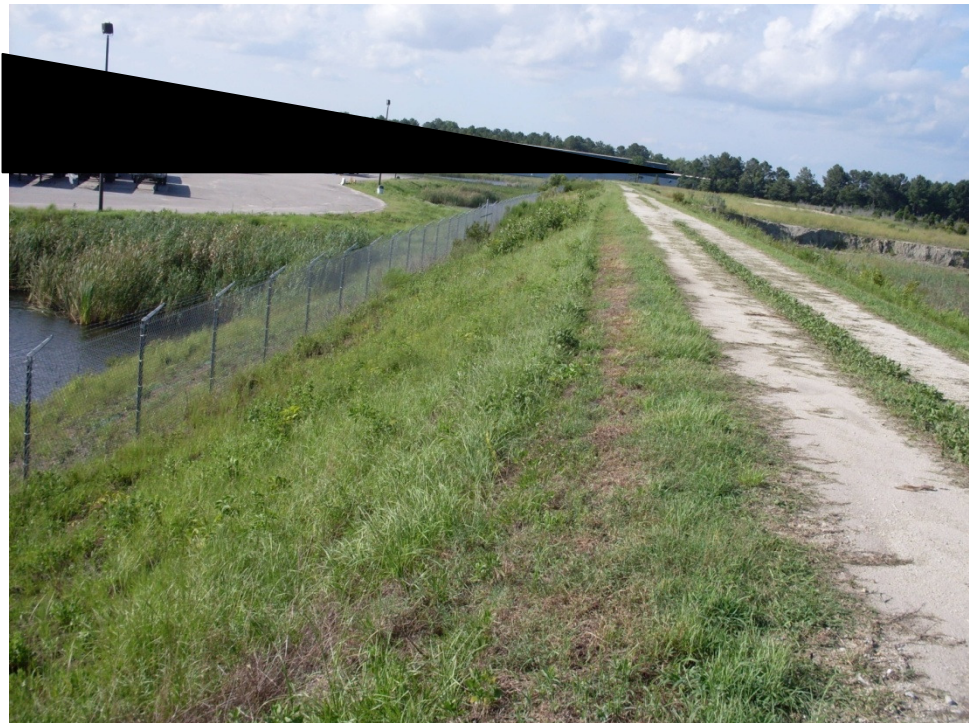
Photo B2-9: Crest and Outside Slope of Perimeter Dike West Side of Unit 2 Slurry Pond– Viewed North.

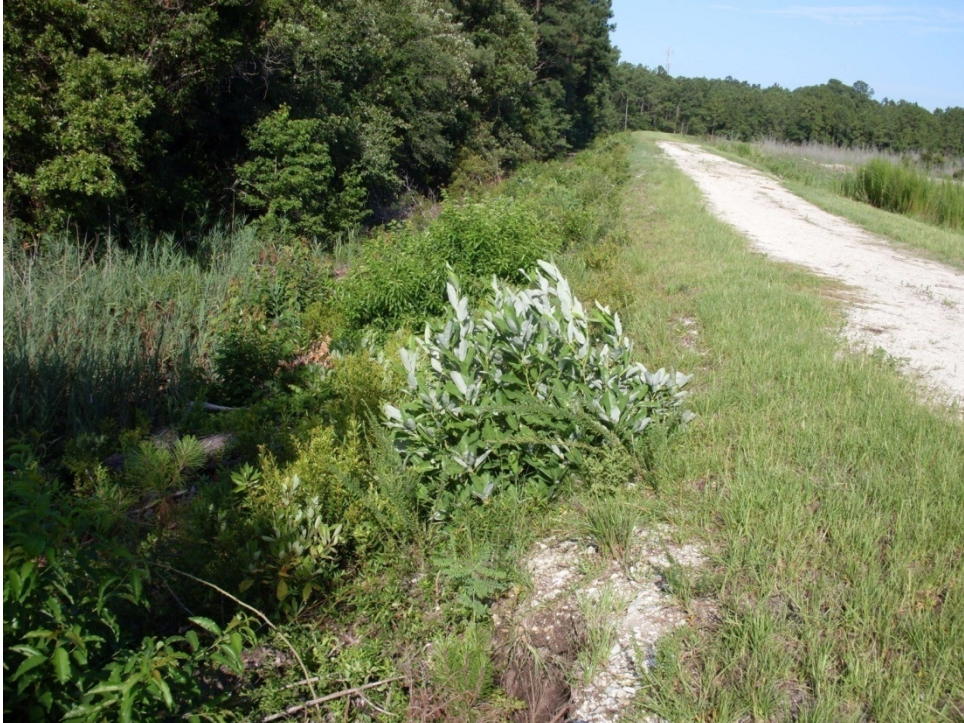
Photo B2-10: Outside Slope of Perimeter Dike North Side of Unit 2 Slurry Pond West of Cross Dike – Viewed East.

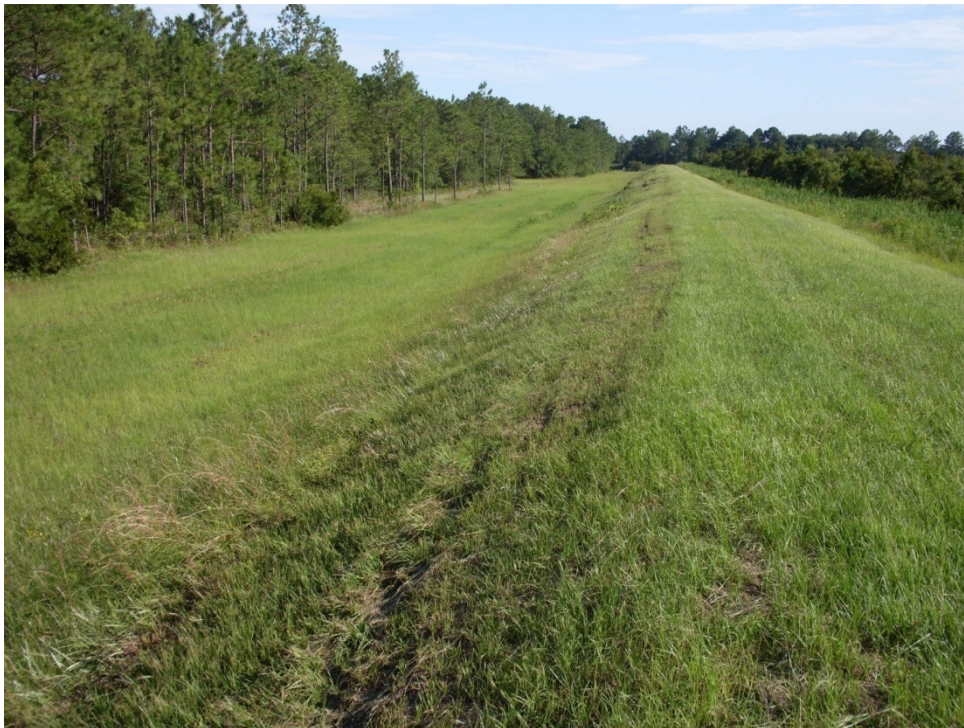
Photo B2-11: Outside Slope of Perimeter Dike East Side of Unit 2 Slurry Pond– Viewed South.

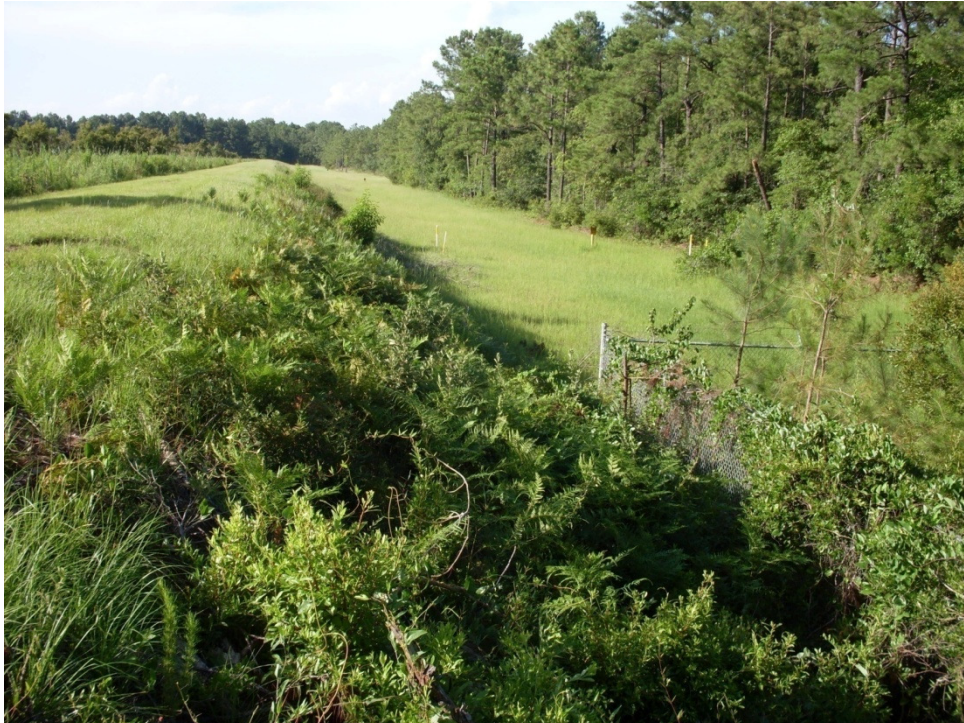
Photo B2-12: Outside Slope of Perimeter Dike East Side near Southeast Corner of Unit 2 Slurry Pond – Viewed South.
